**FOCUSED SITE INSPECTION PRIORITIZATION
SITE EVALUATION REPORT**

**TARACORP INDUSTRIES
MCCOOK PLANT
7753 WEST 47TH STREET
McCOOK, ILLINOIS**

CERCLIS ID NO.: ILD098983208

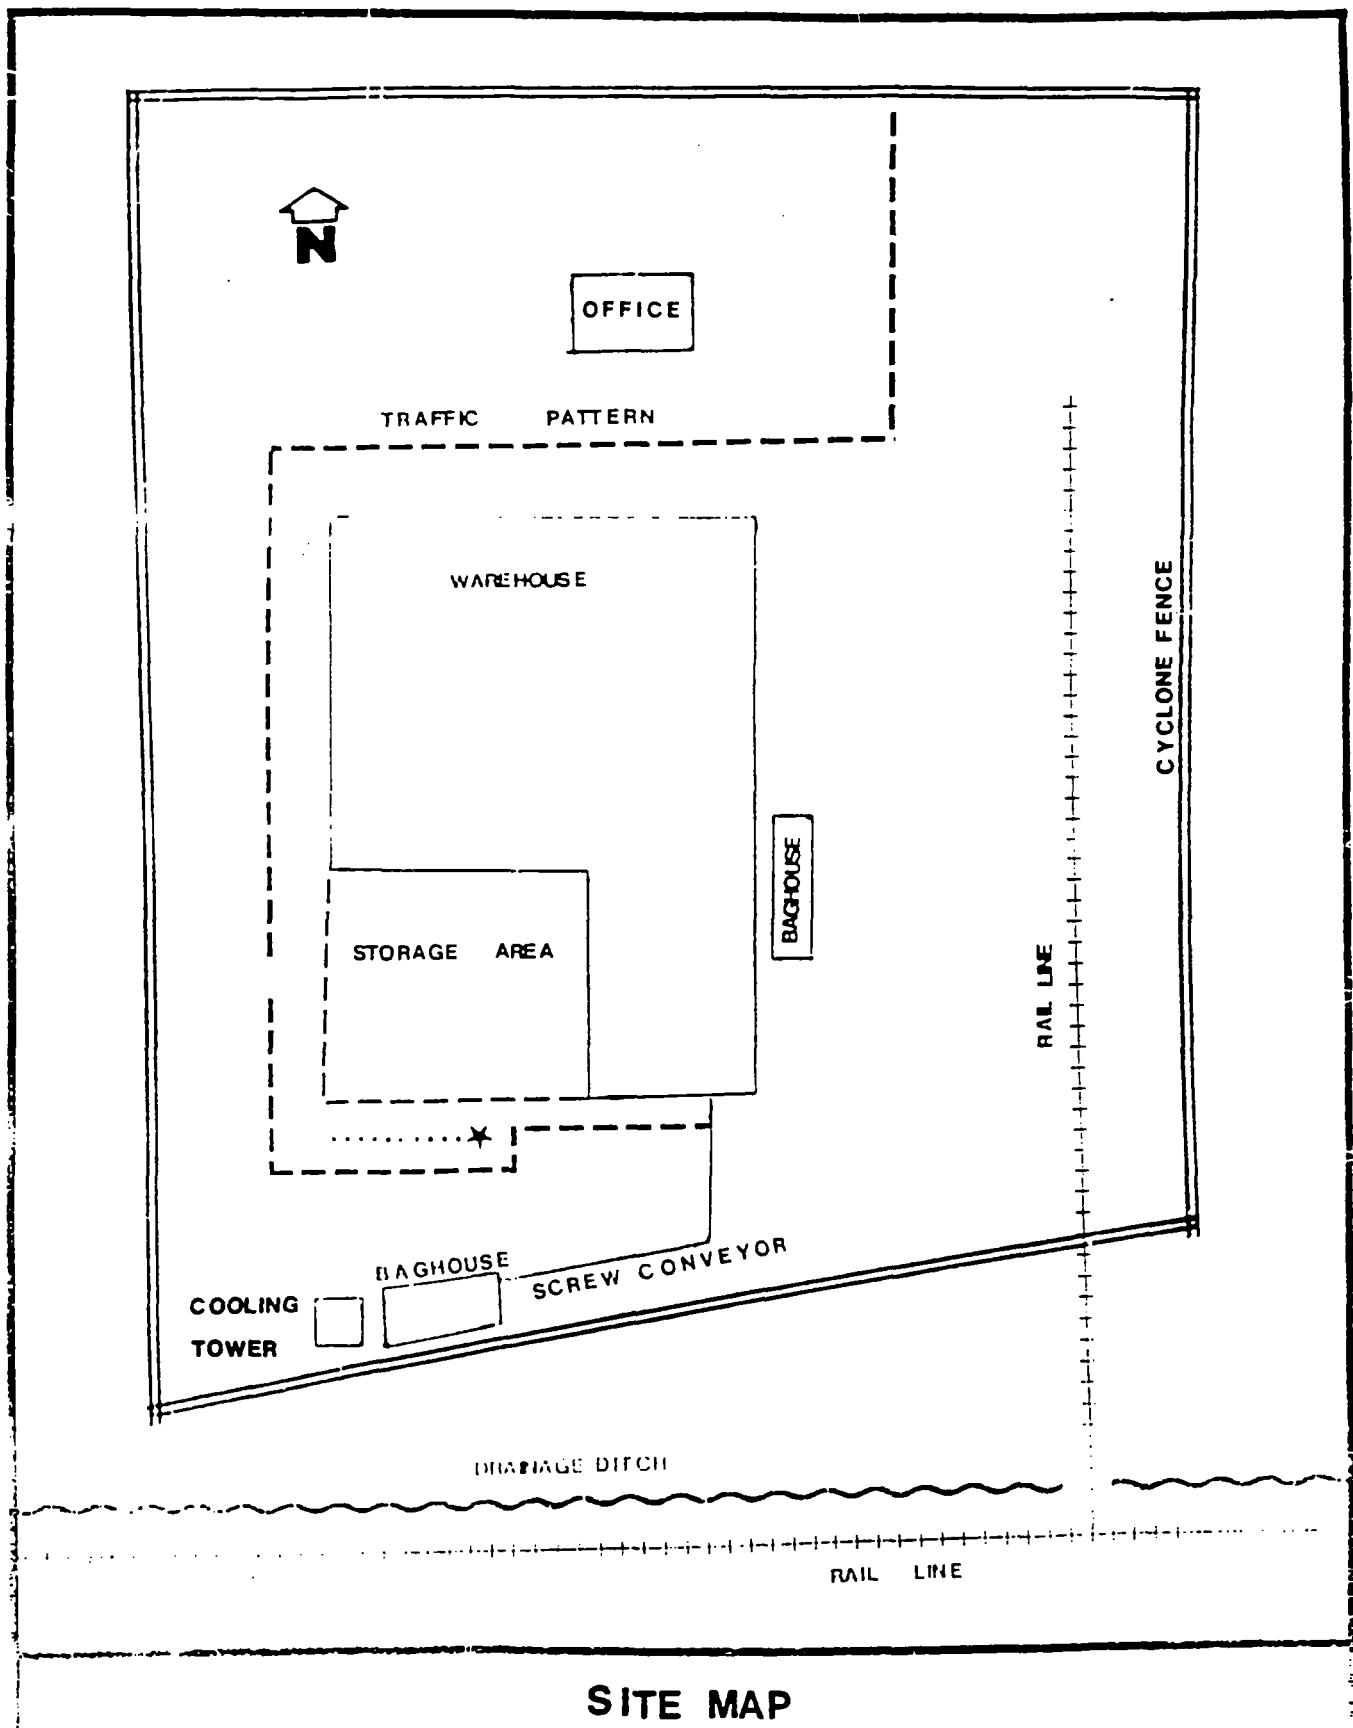
FIGURE 2

- o The concrete pad used for storing lead contaminated material measured approximately 85 feet x 75 feet and was covered by a roof. Walls protected the area on the north and east sides, but no walls were present on the south and west sides (Photograph 1). The concrete on the storage pad was cracked. Dust was also found on the storage pad.

- o A storm sewer drain near the storage pad was plugged and standing water was observed along the storm grate leading to the storm sewer.
- o Broken pieces of battery casings were found on the ground on the east side of the site (Photograph 10).
- o A drainage ditch flowed within a few feet of the south perimeter of the facility (Photograph 7).
- o No defined drainage patterns were detected leaving the site, but the property sloped towards the south and east, which was also the direction of the drainage ditch.
- o Vegetation in the ditches along the site borders did not exhibit signs of stress (Photograph 7).

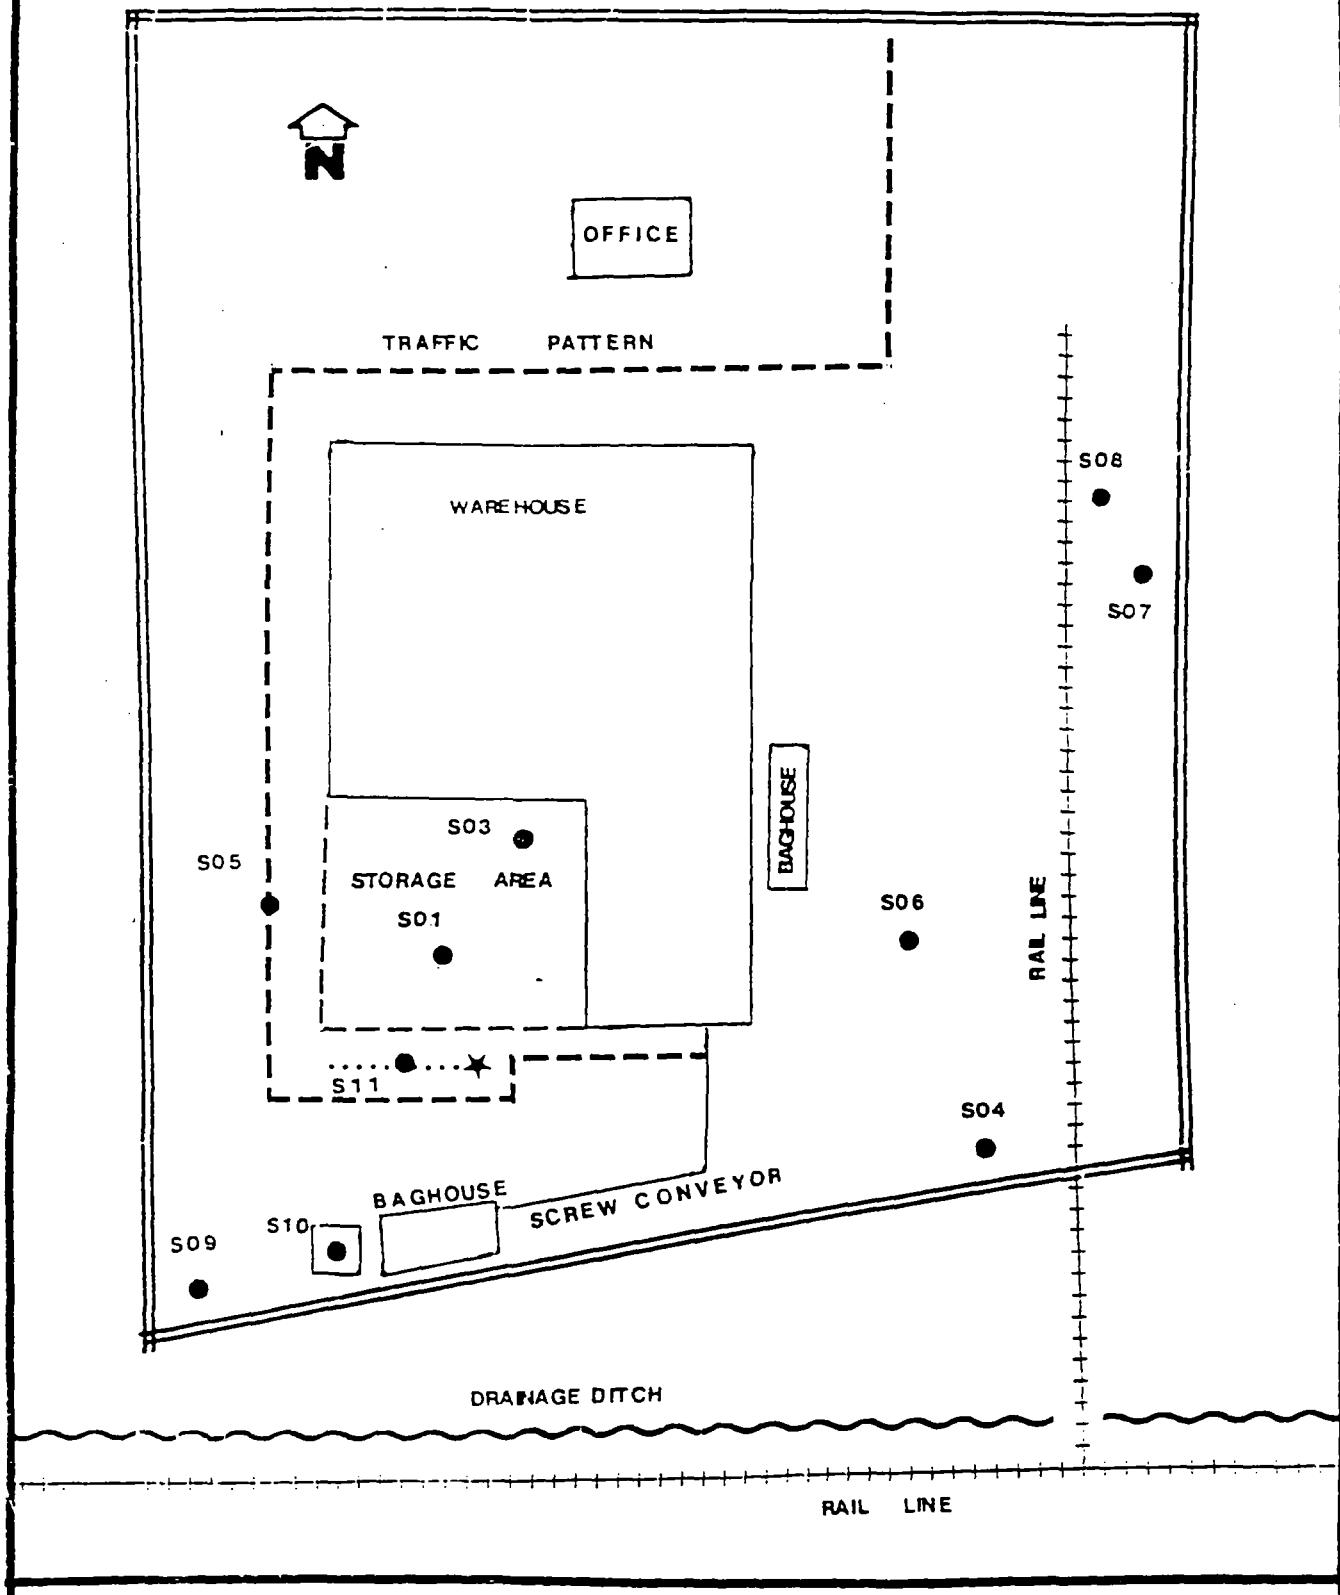
FIGURE 3

limit for typical soils. The sample from the area of broken battery casings near the railroad spur (S08) contained the highest lead level at the site (68%).

Samples analyzed for EP toxicity exceeded the maximum concentration of contaminants for the characteristic of EP toxicity for lead and cadmium at sample station S01 and for lead at sample station S04 (Table 3). These soils exhibit a characteristic of EP toxicity and are, therefore, considered a hazardous waste according to the CFR Title 40 Chapter 1 Section 261.24.

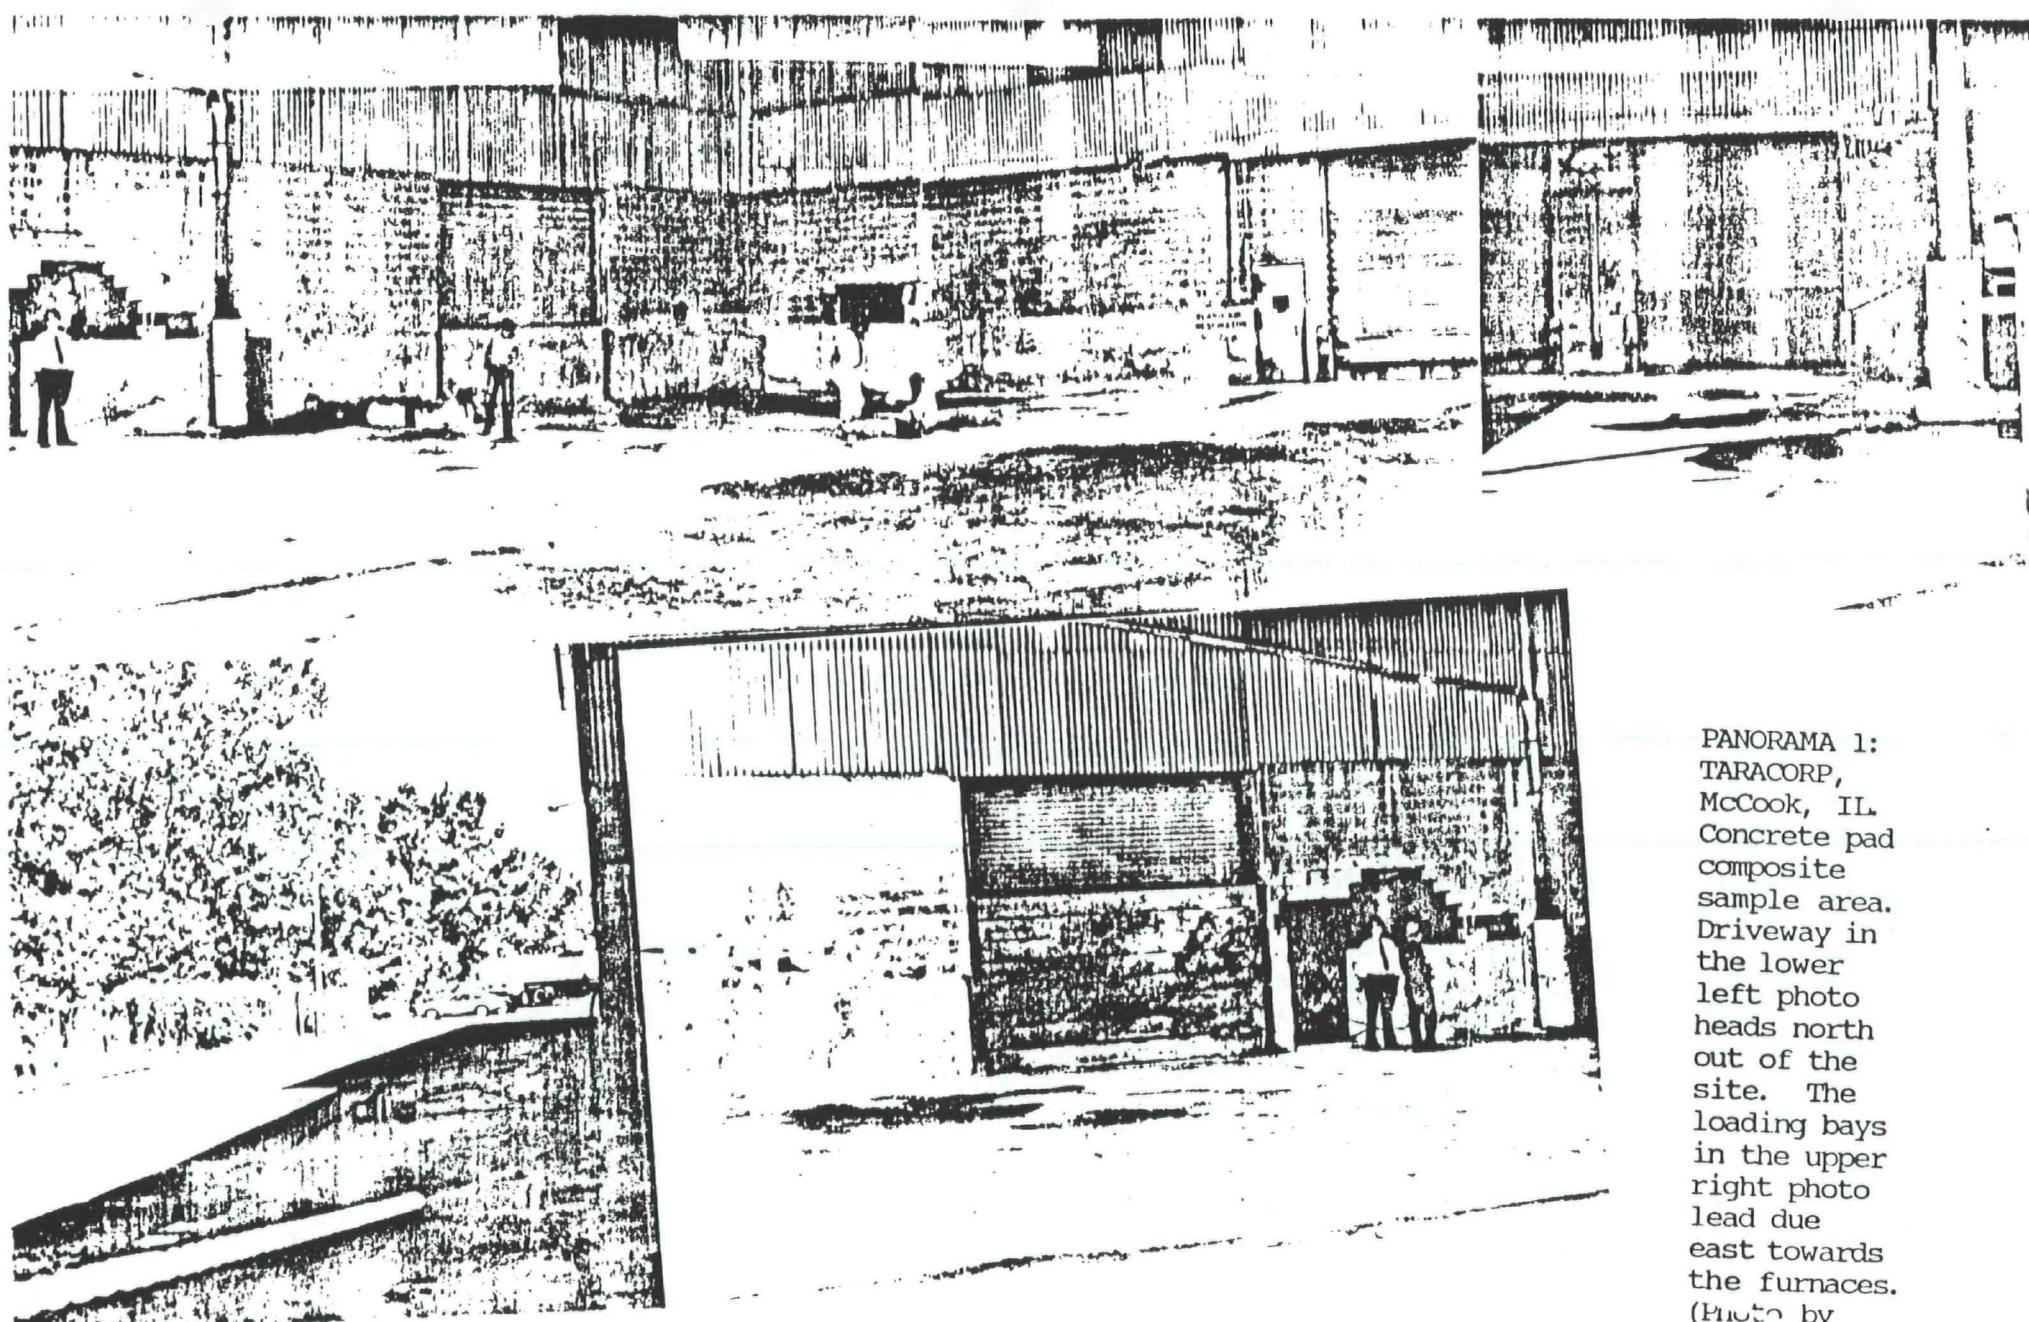
PANORAMA 1:
TARACORP,
McCook, IL.
Concrete pad
composite
sample area.
Driveway in
the lower
left photo
heads north
out of the
site. The
loading bays
in the upper
right photo
lead due
east towards
the furnaces.
(Photo by
Scoville,
1030-1230,
8/28/86.) 2/2

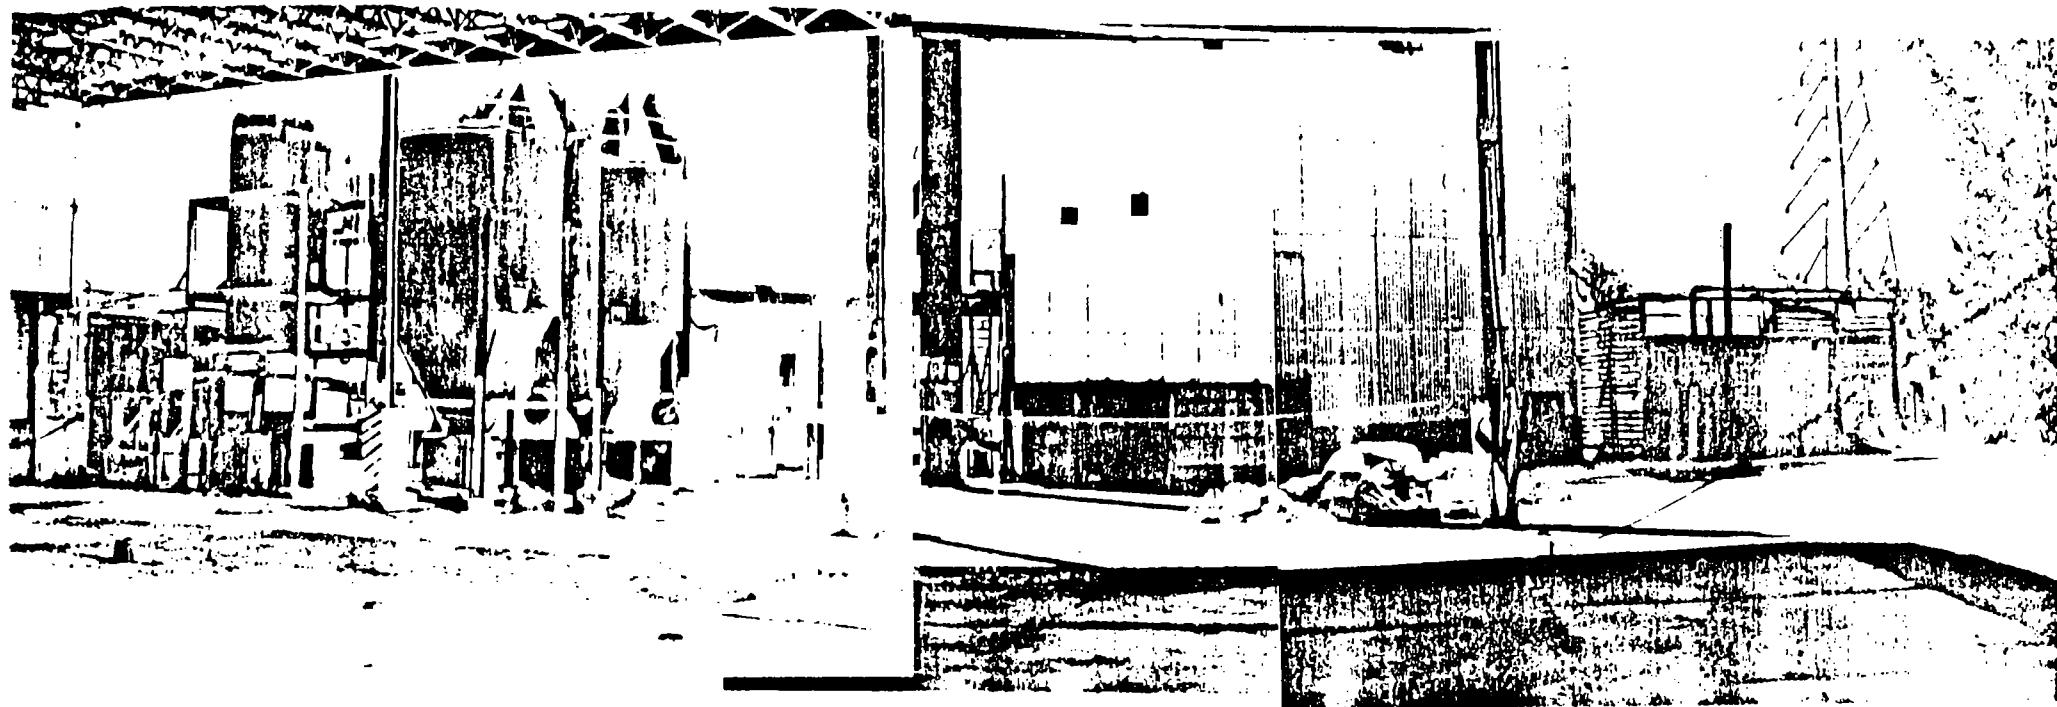
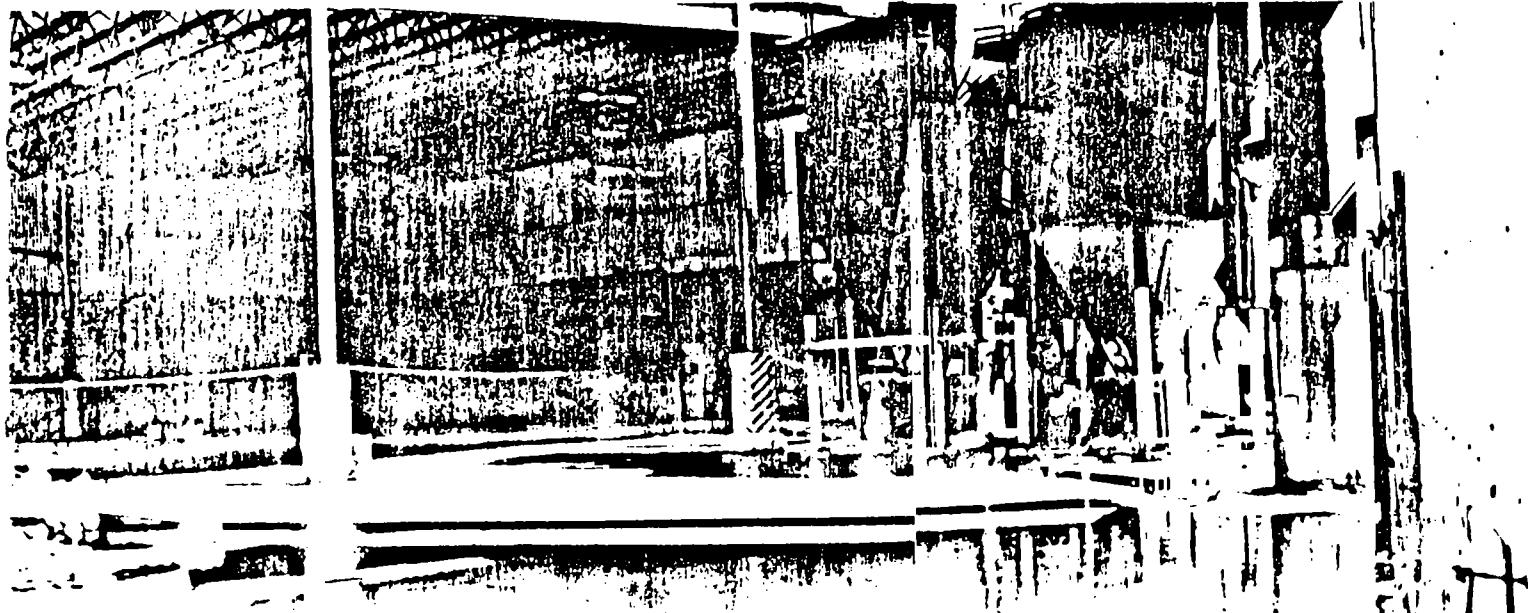
PANORAMA 2:
TARACORP, McCook,
IL.
Samples were
collected of the
water in the puddle
in the lower series
of photos and the
water in the cooling
tower in the upper
right photo. A
clogged drainage
grate leads out of
the puddle in the
lower left photo.
(Photo by Scoville,
1030-1230, 8/28/86.)
L.H.J.

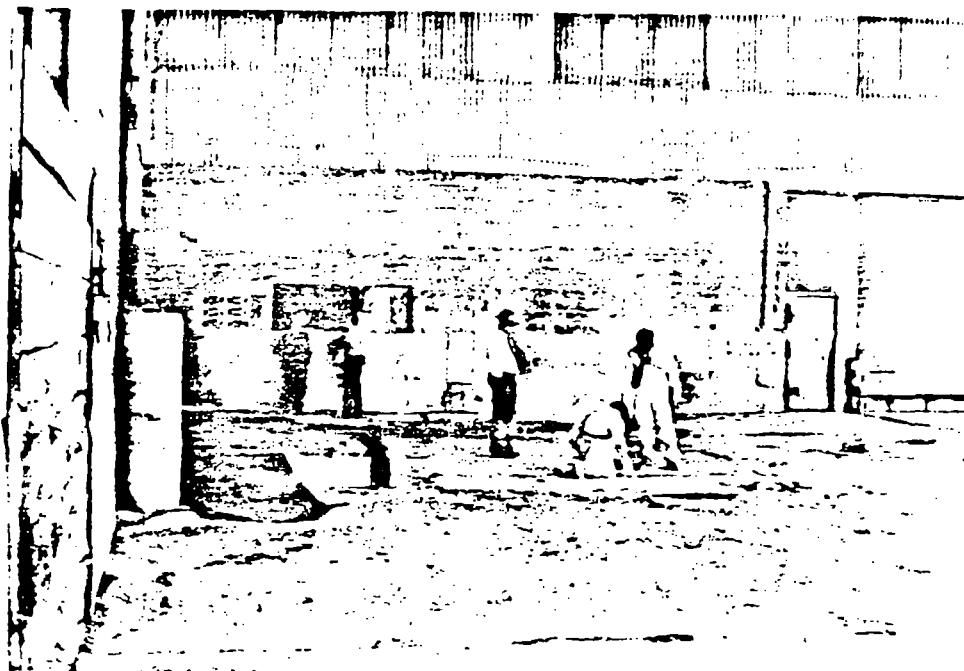
PHOTOGRAPH 3: TARACORP, McCook, Il.
TAT members Lorenz and Babusukumar prepare a composite sample of the concrete pad shown in Panorama 1. Mr. Ron Stoker of Moreco Energy, Inc., observes as George Webb of Taracorp and Walter Francis from the U.S. EPA peer into the interior of the building. Note the sign on the wall advising the use of respirators.
(Photo by Scoville, 1030-1230, 8/28/86.) 213

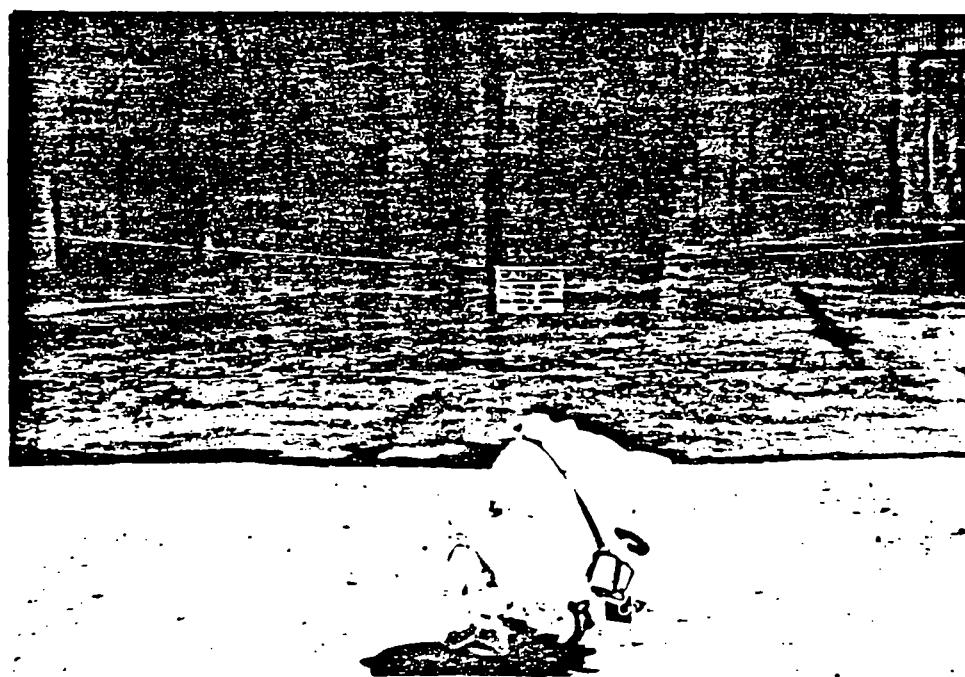
PHOTOGRAPH 4: TARACORP, McCook, Il.
TAT member Lorenz samples a high traffic area west of the concrete pad on the driveway. Caution sign indicates that the area is restricted due to the storage of hazardous wastes.
(Photo by Scoville, 1030-1230, 8/28/86.) 214

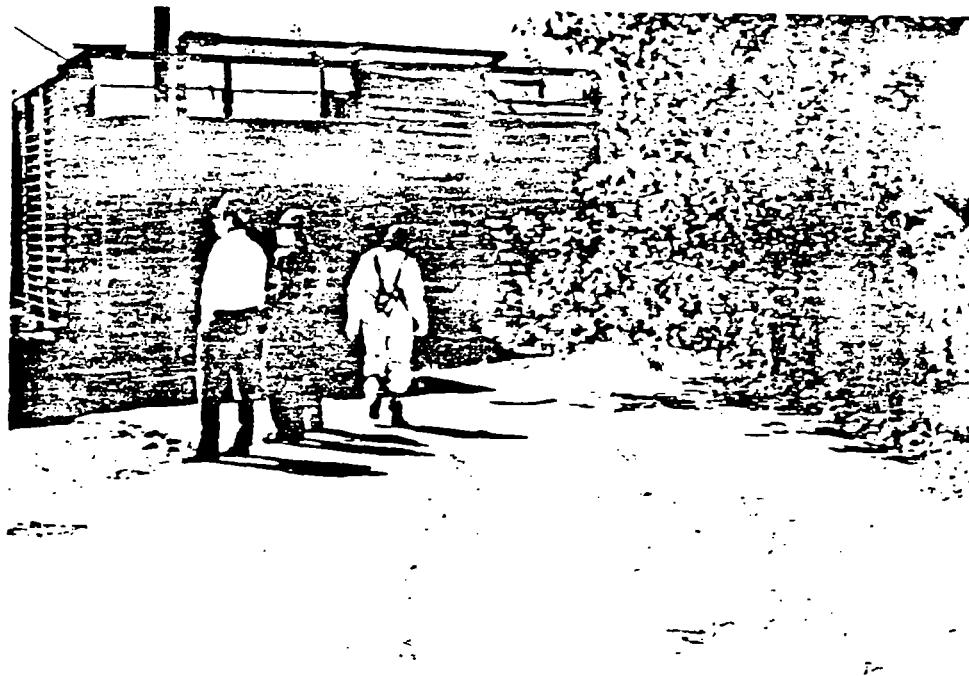
PHOTOGRAPH 5: TARACORP, McCook, Il.
TAT member Babusukumar walks southwest towards a manhole cover near the cooling tower. A soil sample was collected in the southwest corner of the Taracorp property near a drainage ditch.
(Photo by Scoville, 1030-1230, 8/28/86.) 7/1

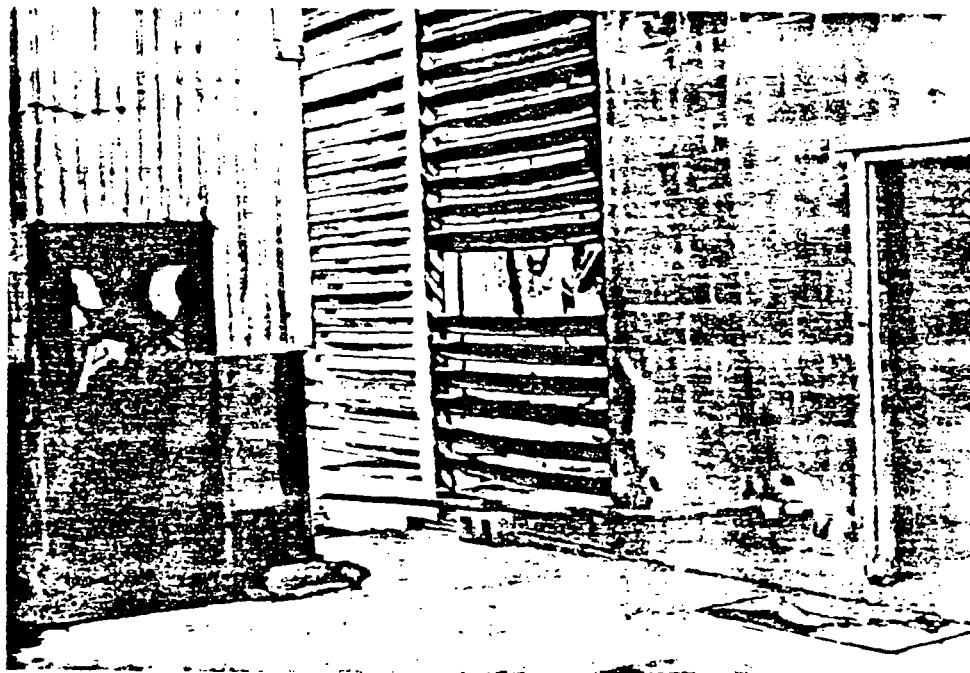
PHOTOGRAPH 6: TARACORP, McCook, Il.
Most of the cooling tower had been demolished.
The water in the area on the other side of the wood panels was approximately 3 feet deep. East of the cooling tower was the bag room, which is shown on the left side of the photo.
(Photo by Scoville, 1030-1230, 8/28/86.) 7/1
